Viking Warehouse Facility Stormwater Outfall Deficiencies Report

The City of Puyallup

February 27 2023

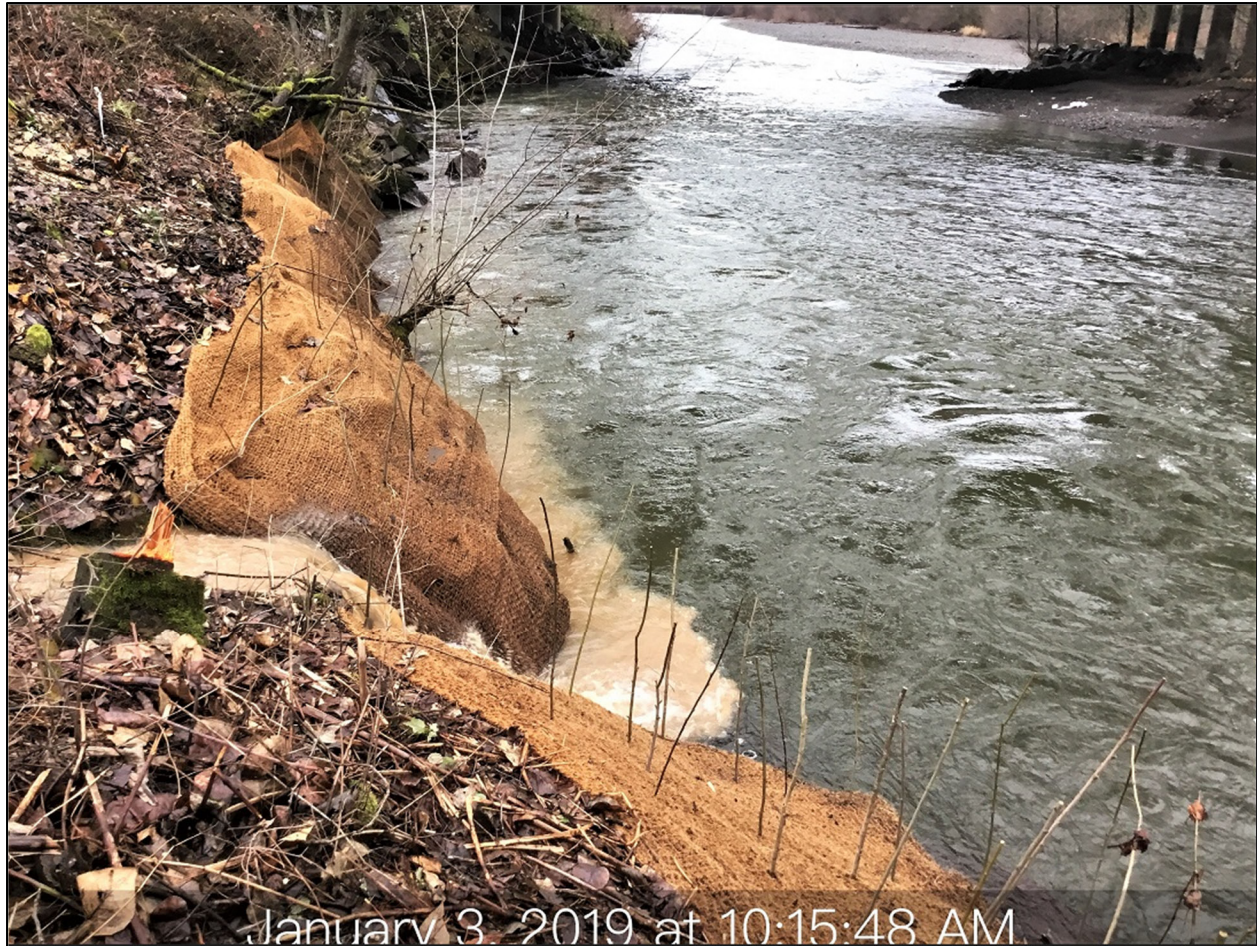
Based on Figure 2.1, initial outfall construction consisted of cutting down trees and installing coir fabric on the bank along with plantings sometime in the winter of 2018/2019. It appears from the figure that the coir fabric was simply draped over the existing bank with minimal to no grading, based on the visibly lumpy surface. It also does not appear the coir was secured in place with any significant staking other than the plantings themselves. It is not known how the bottom of the coir blanket was secured. In the fall of 2019 additional coir was added to the top of the bank, it appears that the original coir lower on the bank was left in place. The full outfall was also constructed at this time. Based on Figure 2.1, recent site visits and the apparent ability to install the plant cuttings in the bank, we assume little to no riprap was encountered during any of the bank construction activities.

Figure 2.1: Initial coir installation, January 2019 or earlier. Note stormwater from pre-project outfall.

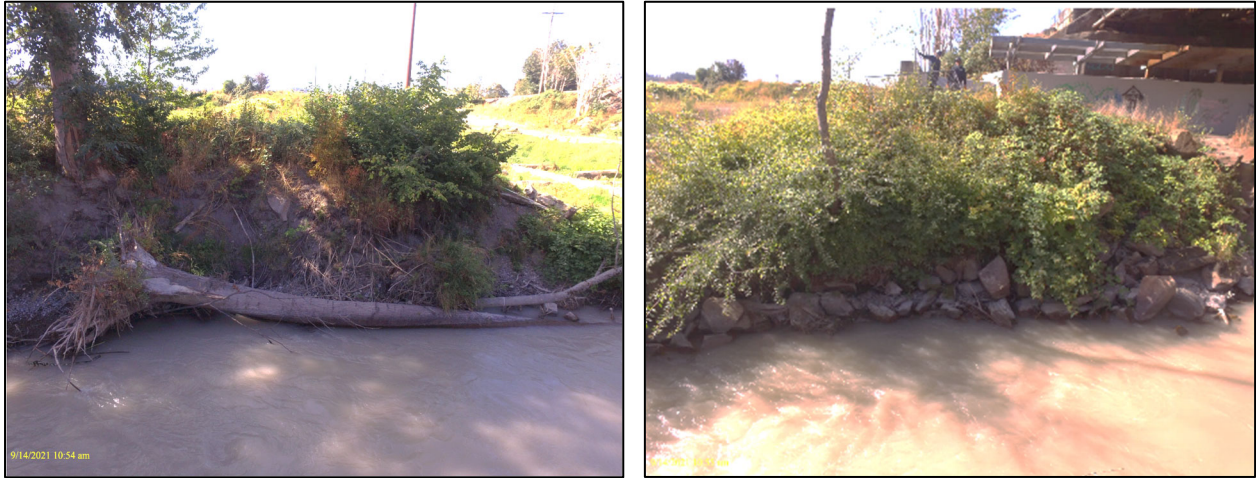
The bank immediately upstream of the outfall is eroding. Several trees have fallen in the past few years and a vertical soil bank is exposed. No riprap is visible in this bank, as compared to the bank on the downstream end of the outfall Figure 2.2. The erosion is clearly visible comparing 2011 and 2020 LiDAR (Figure 2.3).

Figure 2.2: Banks upstream (left) and downstream (right) of the outfall, Sep 14, 2021, Balmelli.

Currently some erosion protection is being provided by fallen trees lining the bank, but these are deciduous and expected to decay or be washed away in the next few years. Further bank erosion here could flank the outfall and erode under the upstream edge of the Armorflex.

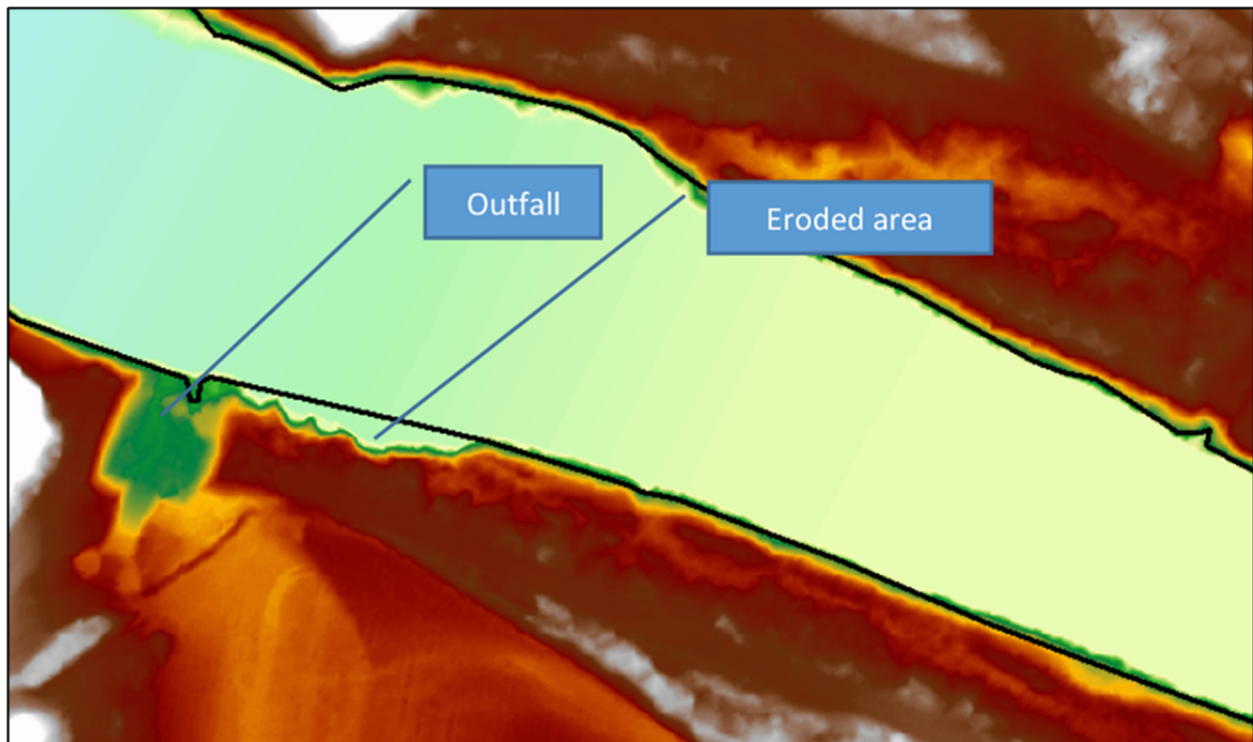
Figure 2.3: 2020 LiDAR topography with 2011 bank line in black showing bank erosion upstream of the outfall.

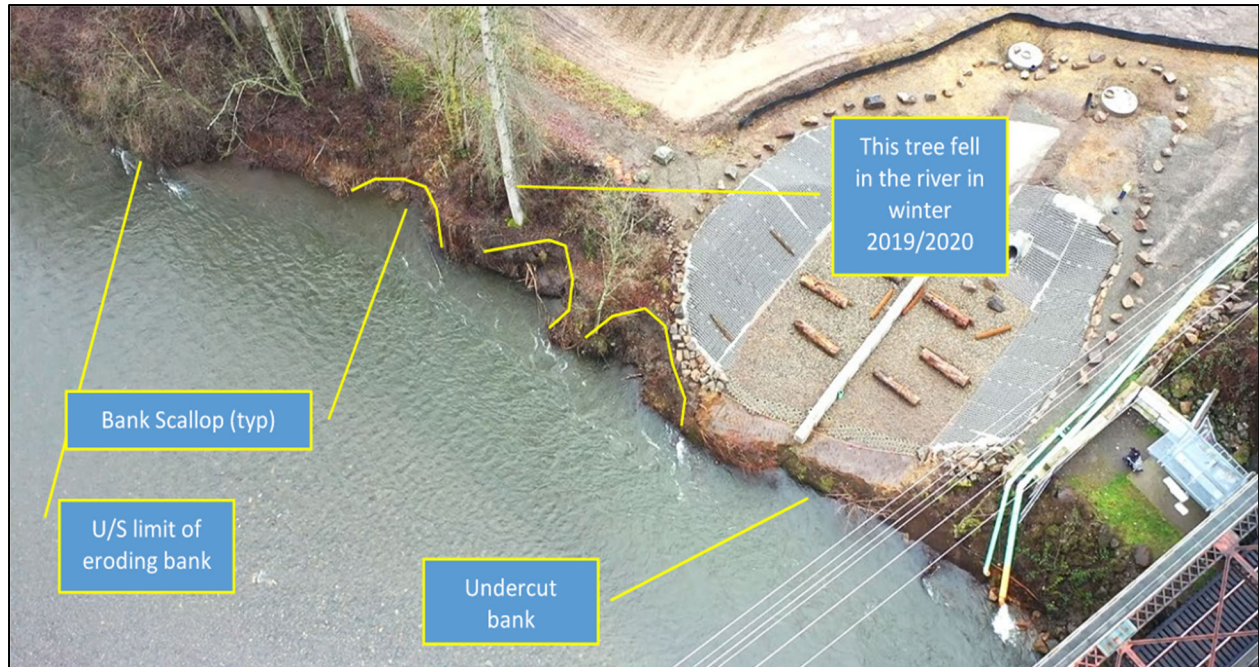
Figure 2.4: December 2019 UAV image annotated with erosional features.

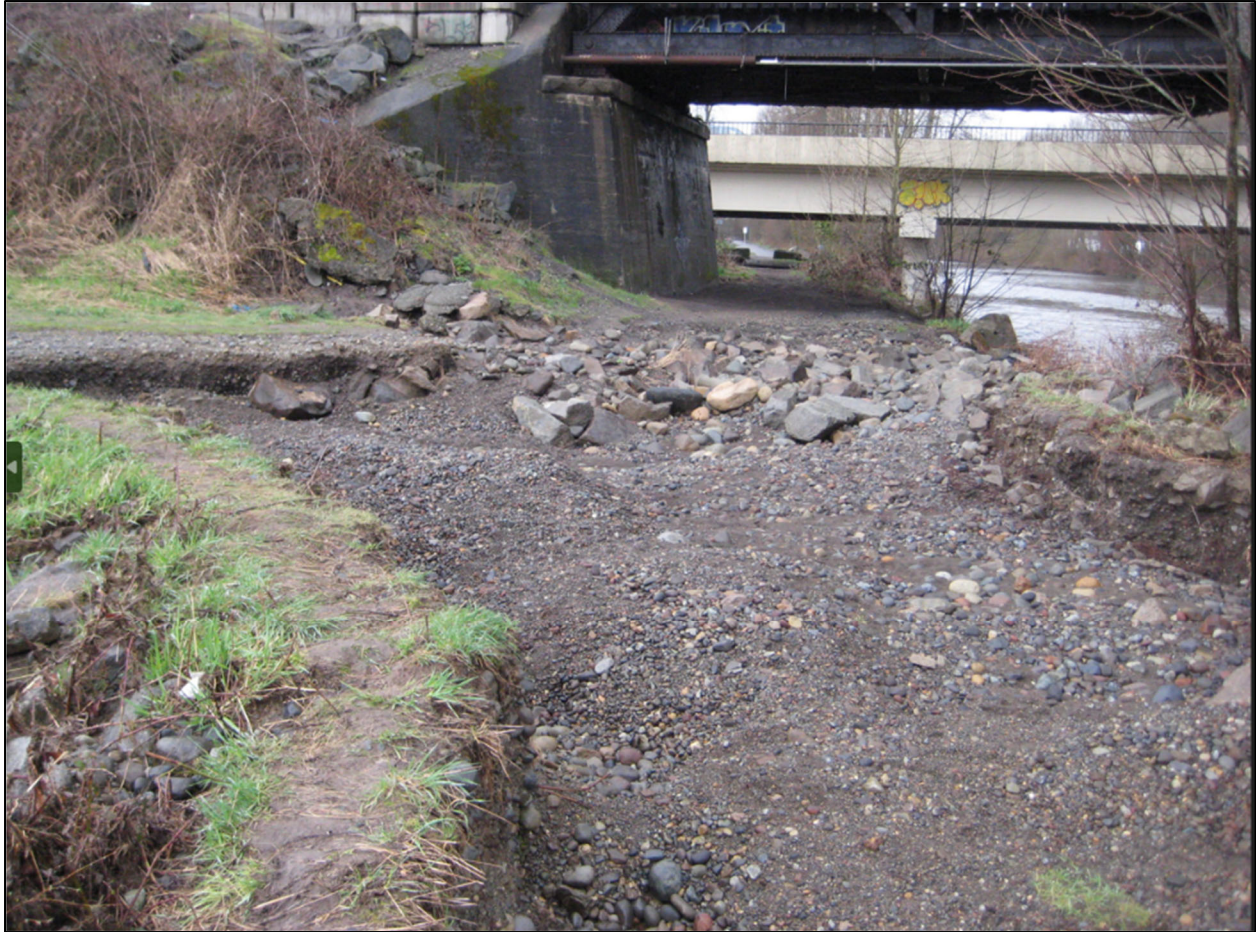
The location of the outfall has historically been a point where overbank flood flows return to the river channel due to the blocking of the floodplain by the railroad embankment. These flows accelerate over the bank and drop into the river channel, creating high velocities and shear stresses on and near the bank. The effects of this can be seen in post-flood photos from the large January 2009 event, where velocities were high enough to strip off turf and scour into the levee prism (Figure 2.5). The location of damage shown in Figure 2.5 corresponds well with maximum velocities under the pre-project conditions predicted by the WEST Consultants hydraulic model (top, Figure 2.6).

Figure 2.5: Scour and erosion of levee due to January 2009 flood at the location of the current outfall.

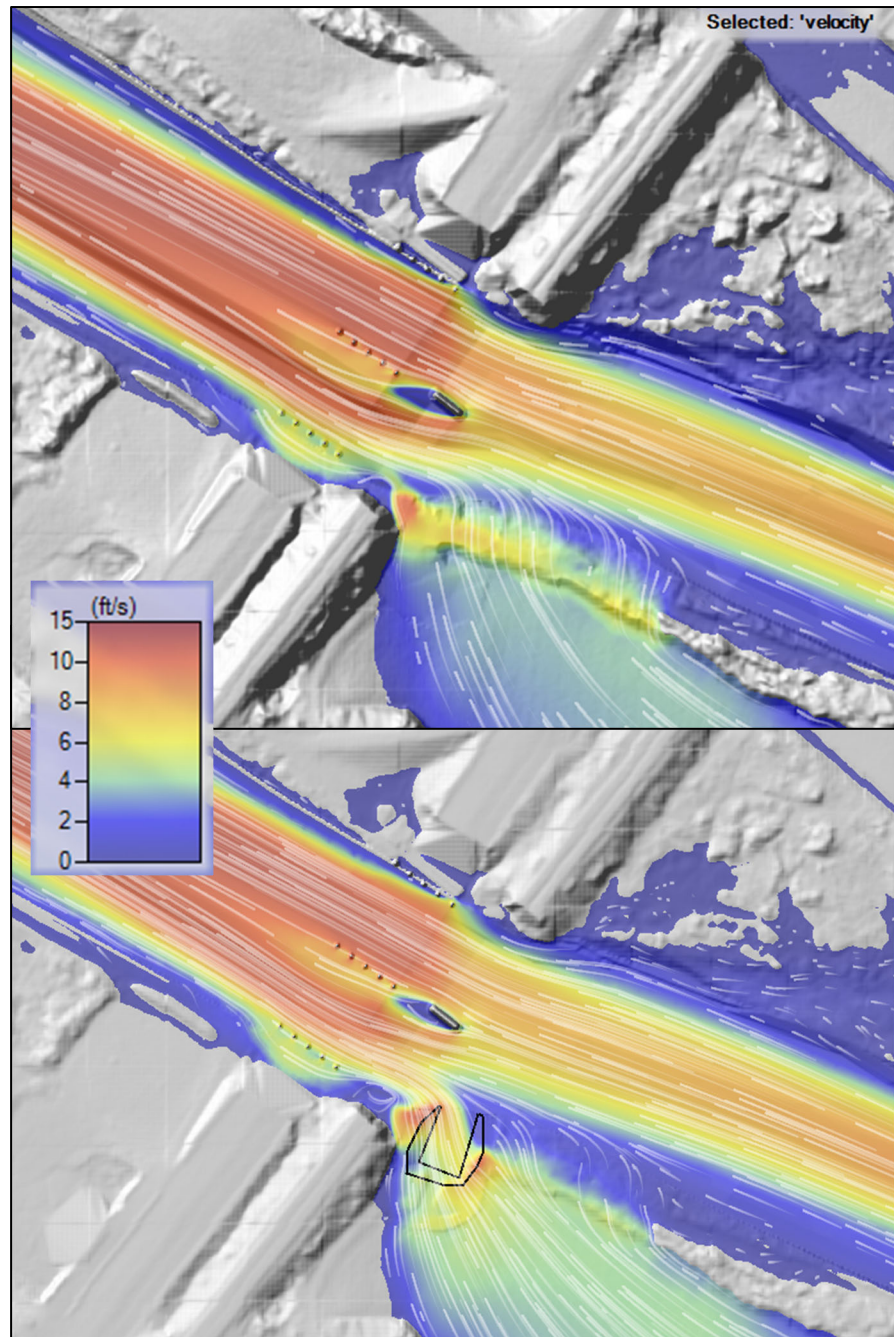
Removal of the levee and then further lowering the ground level for the outfall has created a point of concentration for these overbank flows returning to the river during floods. While this was always the case at this location, the outfall has increased flow velocities, concentration of flow, and shear stresses. Figure 2.6 shows results from the WEST Consultant hydraulic model of the site used to evaluate scour risk. Velocities are increased in the area of the outfall as the return flows accelerate into the main channel. Velocity hotspots exceed 10 ft/second on both the up and downstream edges of the outfall. While the Armorflex layer is likely capable of withstanding this, the high velocities also occur outside the limits of the Armorflex. The upstream high velocity area is of more concern due to the lack of erosion protection measures outside of the Armorflex. Downstream of the outfall and transitioning into the bridge abutment, riprap is visible, appears to be in generally good shape, and the modeling indicates it has likely been repeatedly exposed to these high velocities in prior floods. Furthermore, the site has been exposed to a 10-year and 25-year flood since construction with no apparent overbank damage around the perimeter of the outfall, so this risk appears to be less of a concern than the other types of ongoing erosion at the site.

Figure 2.6: Velocity magnitude and flow path under pre-project (top) and post-project (bottom) conditions for the 10-year flood. Outfall outlined in black. Results from WEST HEC-RAS model.

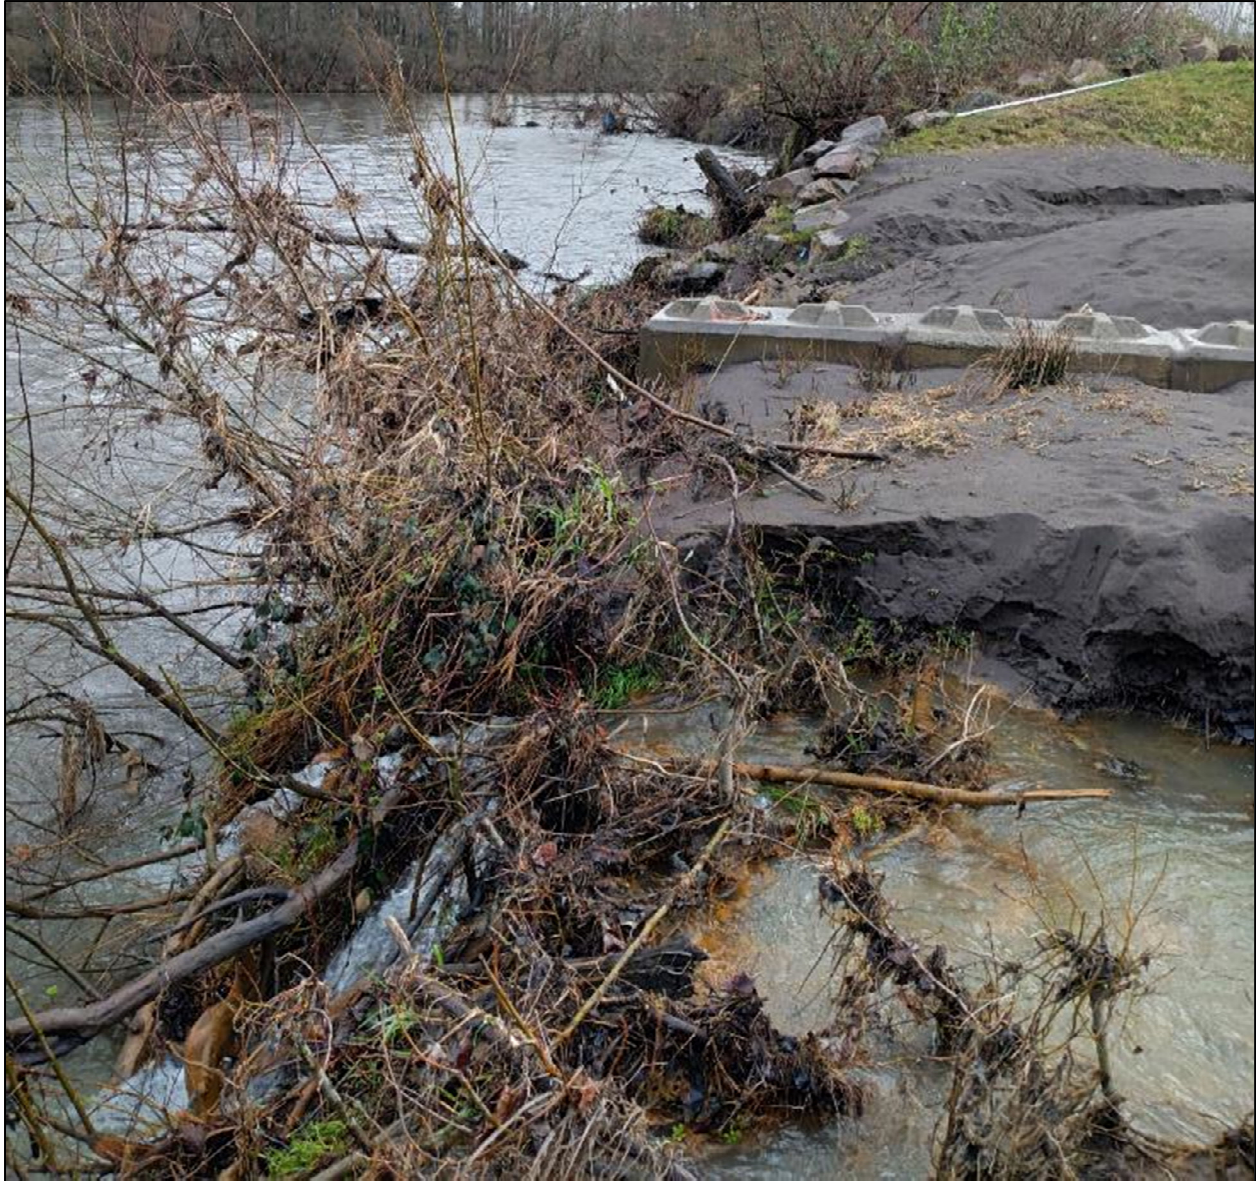
The outfall design appears to follow a standard Contech outfall energy dissipation design using Armorflex and A-Jacks. This design may be appropriate where a pipe discharges into a conveyance channel that continues downstream far past the outfall at a moderate slope. However, in this case the design did not address the need to convey stormwater into the river channel down a far steeper riverbank slope. The outfall design appears to have assumed that a steep bank comprised of native vegetation could withstand continuously saturated soil and continuous seasonal and storm flows flowing down over it without damage while allowing plant growth. This is not a situation observed in any natural system and is not a condition we believe could ever be made sustainable. Flows have concentrated and eroded the bank, undermining much of the vegetated berm (Figure 2.7). The undermining has progressed to the point where the A-Jacks have started to fall down the bank and some of the bedding rock underlying the Armorflex is now visible. The point of undermining has varied over time as extensive overbank deposition of sediment has resulted in the concentrated flows attacking varied locations on the bank. This erosion is occurring under small, non-storm flows far less than those that will be generated once the watersheds are fully developed.

Figure 2.7: Concentrated flow spilling over, eroding, and undercutting vegetated bank. March 15, 2022, NHC.

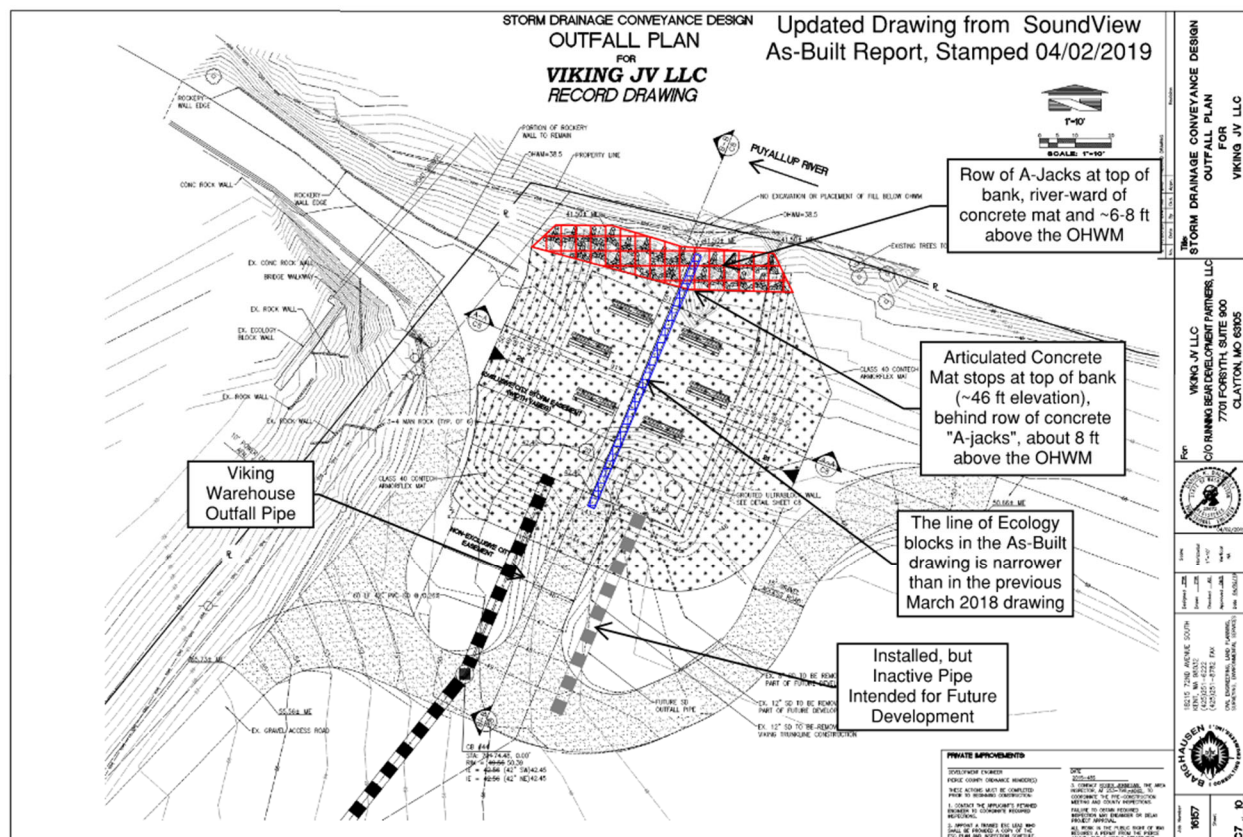
Figure 3.3: Adapted plan view of As-Built changes from the originally approved outfall structure design.

- In 2020, the Contech articulated mat is shown as stopping near the top of bank, about 10-15 ft landward from the OHWM (Figure 3.3 and Figure 3.5) at about 46 ft elevation, rather than the 2018 design (Figure 3.1, Figure 3.2, and Figure 3.4) which showed the articulated mat extending over the top of slope and down the bank to 2 ft below the 38.5 ft elevation OHWM.
 - No engineering documentation was provided to explain why this change was made. From a permitting standpoint, this revision would eliminate direct hard-armor impacts to the river (a Water of the US [WOTUS]), and also avoided federal review of the outfall structure and associated new impacts to the Puyallup River.

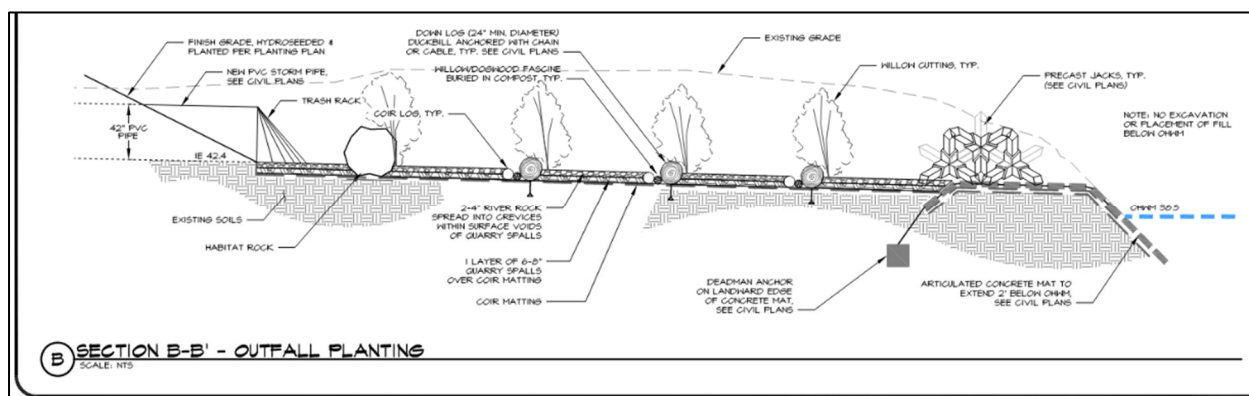
Figure 3.4: Side view of original (2018) approved outfall structure design.

- The A-Jacks which previously were situated above the Contech mat at top of the bank (Figure 3.4) were instead installed on top of a coir fiber mat laid over a constructed soil berm at the top of the riverbank (Figure 3.5). The coir mat starts about 10-15 ft landward from the top of the bank and extends riverward to below the OHWM. The top of bank berm was subsequently planted with willow wands (see Figure 3.5).

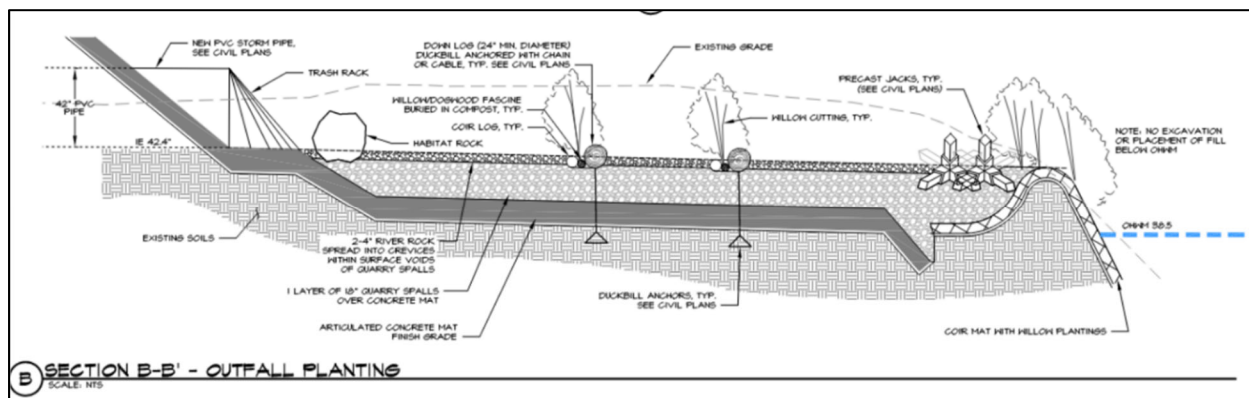
Figure 3.5: Side view of As-Built (2020) changes from the originally approved outfall structure design.
